NDT DAMAGE DIAGNOSIS ON SANDSTONE – Case Study of Gelnhausen, Germany

Christoph Franzen*; Thomas Löther*; Michael Auras** and Enno Steindlberger**

Abstract:

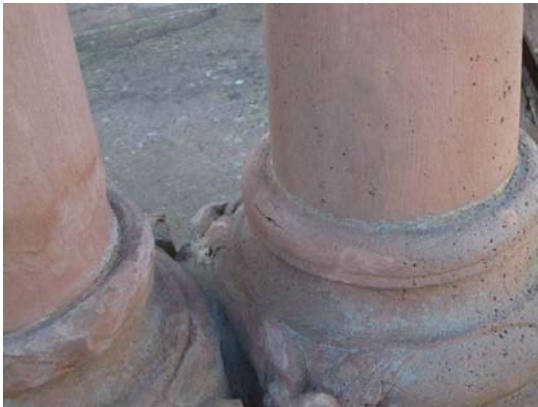
The sandstone Base No 3 shows in some parts pits looking like an enlargement of the natural porosity (Fig.2). On the upper roll moulding of the base a blistering was observed, following the stone deterioration terminology recommended by Vergès-Belmin et. al (2008). Active IRT (Fig. 3) showed that the detachment is traceable and does not exceed the visible damaged area. The thermogram is given as difference-temperature; solely the temperature difference to the temperature distribution at the start of the investigation is shown. This neglects temperature irregularity present at the beginning of the investigation. Interpretation of the thermogram is made difficult due to the three-dimensional structure of the part investigated. Overhanging slim parts heat up faster than massive parts

Figure 2: Base No 3 (right).

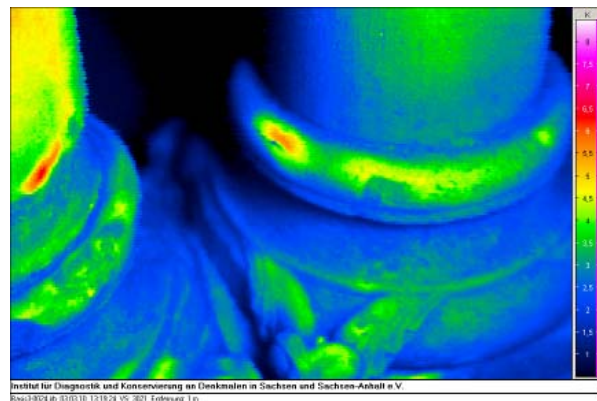
Figure 3: Active IRT on Base No 3.

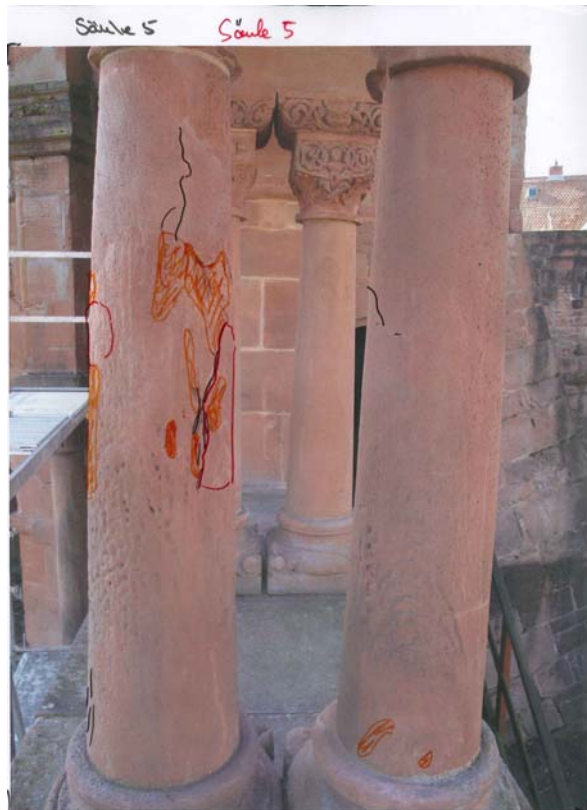
On pillar No. 5 (Fig. 4) active IRT was conducted. The pillar shows differential erosion and alveolisation in its lower parts. Previous typical damage investigation assumed subsurface detachments in the middle part of the pillar. This part was taken for specified investigations. Heater was placed normal to the central part of the pillar at a distance of 1.3 m for 300 s. Every 5 s IR-thermogram was captured. The total measurement sequence covered the activation and the cooling phase of the area investigated (Fig. 5, 6). Also here interpretation was done on the difference-temperature-thermograms.

Figure 4: Pillar 5 (left), previous damage mapping, suspicion of subsurface detachment areas.
