Landesgewerbeanstalt Bayern

Security in the sign of the Nuremberg Wall

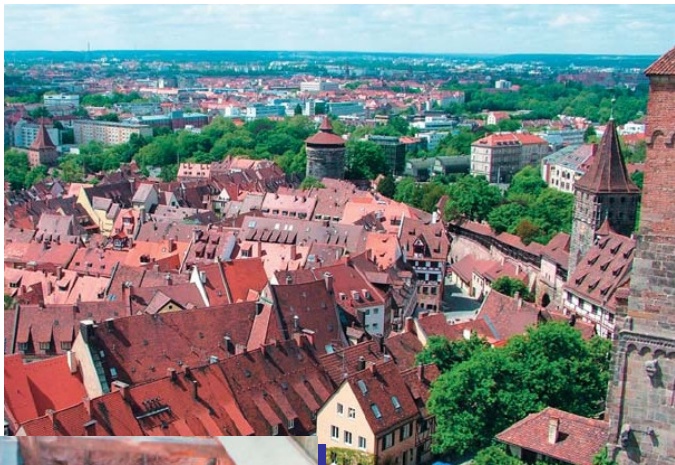
The Nuremberg city wall is getting a bit long in the tooth and loses more and more stability. Among other things that is due to the fact that the building constructed in the 14th century for the most part consists of sandstone. To add to stresses and strains, e.g. vibrations of heavy load and tramway traffic - nobody thought about that in the 14th century. So it happens that

suddenly off-sets of several cm can be found. In some places have been prominent cracks noticed.

most important places of the wall online 24 h a day monitored. For this purpose a total of 52 displacement sensors get inserted into the wall, to register least displacements. The signals get recorded with the data logger IDL 101, which continuous the actual values with the set points compared and the data via modem to the PCs of LGA and Civil Engineering Office transmit. At exceeding of the limit values an alarm will be activated at the monitoring system and a SMS automatically will be transmitted to the mobile phones of the Civil Engineering Office.
